Identifying Number MPC-354

Geotechnical Limit to Scour at Spill-through Abutments

The University of Wyoming

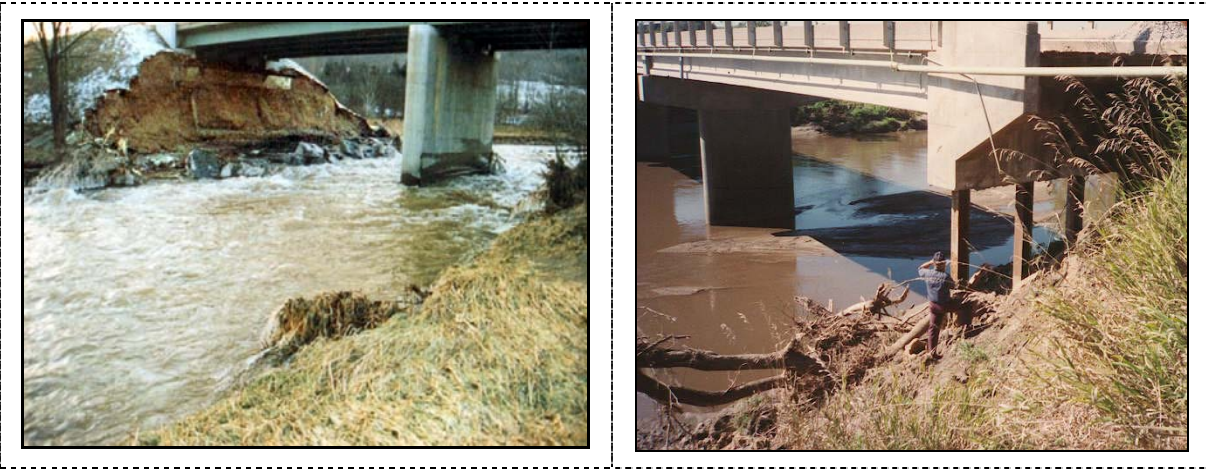
Figure 1. Abutment failure due to scour typically is attributable to the geotechnical failure of the abutments spill-slope, as illustrated by these two examples.

Most cases of abutment failure attributable to scour show a geotechnical failure of the spill slope of earthfill embankment associated with the abutment. The abutment column typically remains standing. Figure 1 illustrates two typical examples. Because spill-slope failure increases the flow area through a bridge waterway, and deposits material in the scour area, the maximum scour depth attainable at an abutment, and damage sustained by an abutment, appears to be limited by the geotechnical stability of an abutment's earthfill embankment. However, the relationship between scour and geotechnical stability of a spill-slope or embankment has never been investigated. The proposed study will be the first to investigate the relationship.

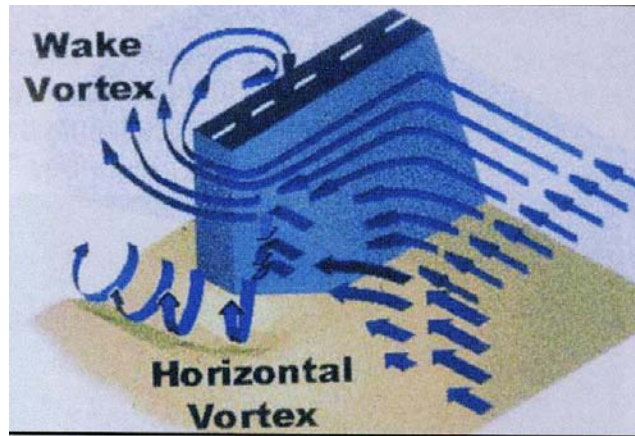
Figure 3. This sketch portrays an unrealistic, or at least very uncommon, view of abutment scour; taken from NHI (2009) "Stream Instability, Bridge Scour and Countermeasures"

The leading design guides, and bridge-monitoring guides, inadequately characterize scour at bridge abutments. For example, the recent FHWA publication NIH (2009) "Stream Instability, Bridge Scour and Countermeasures," for instance inaccurately portrays an abutment structure and its flow field, and says nothing about how abutments actually are built, and possibly fail subject to scour. Figure 3 is taken from the publication. A similar comment can be made for the FHWA design guide HEC-18 (Richardson et al. 2001).
