MPC-526 Seismic Repair of Concrete Wall Piers Using CFRP Active Confinement

Seismic Repair of Concrete Wall Piers Using CFRP Active Confinement

Chris P. Pantelides, PhD, PE, SE, University of Utah, Salt Lake City,
Utah, USA

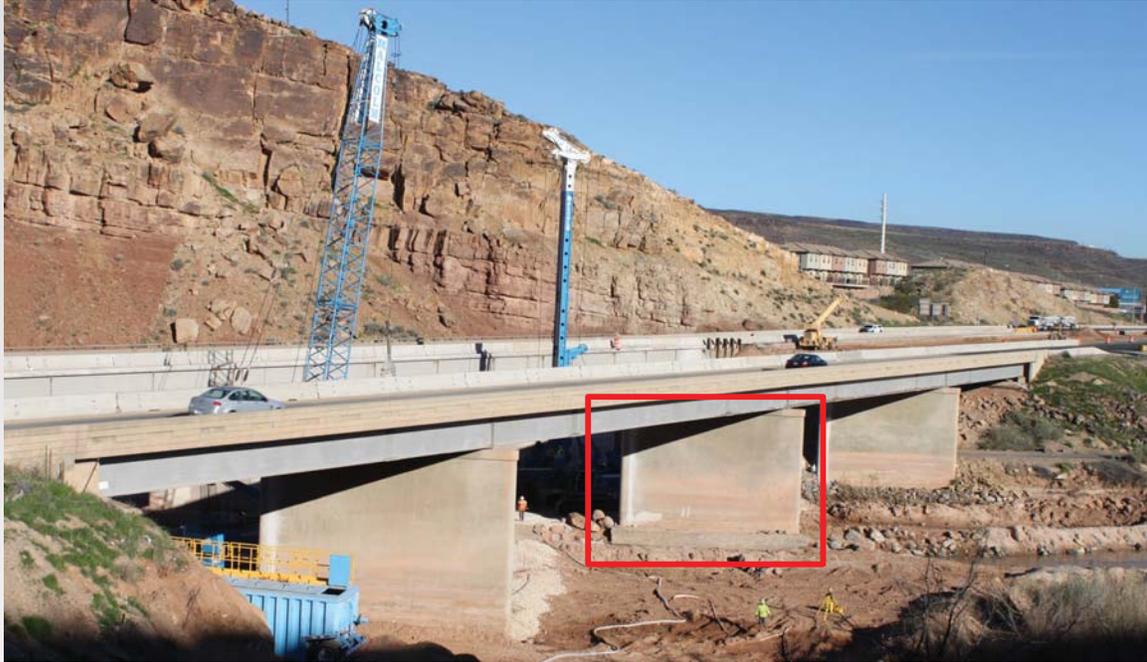
Bridge built with Concrete Wall Piers in Utah

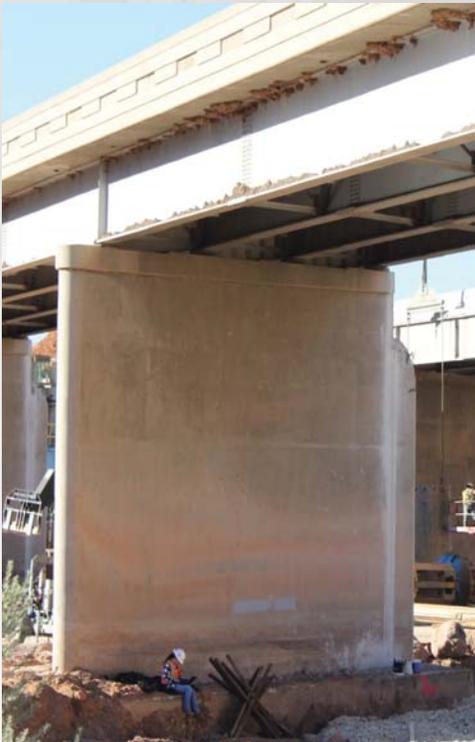
- Constructed prior to AASHTO Bridge Design Code in 1970's
- Designed to support gravity loads
- Not design for seismic loads

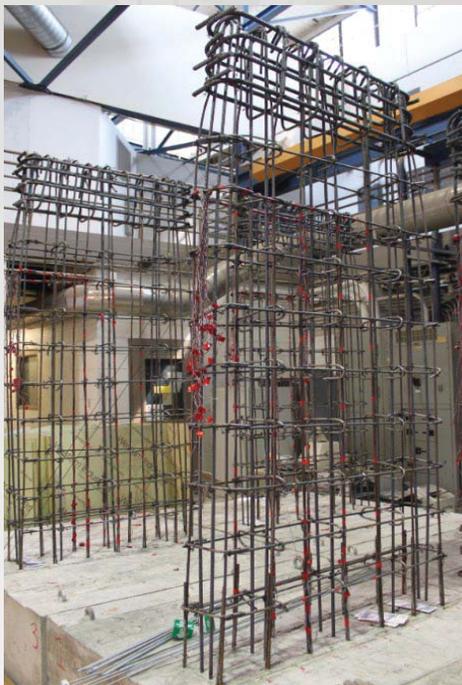
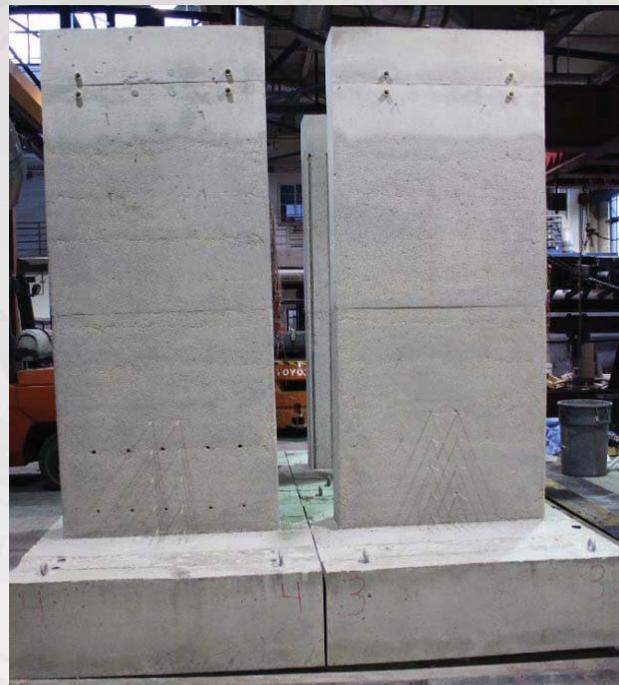
- Half-scale specimen of actual wall pier

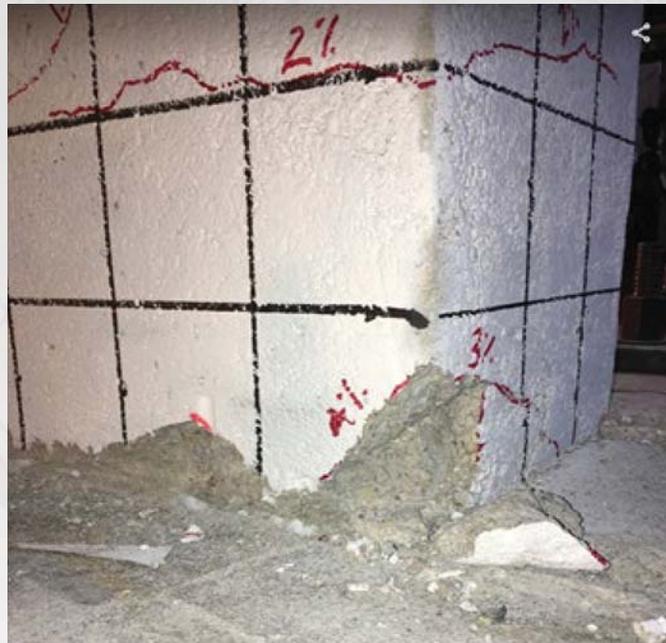
Failure Mode: Lap-Splices

Spalling at 4% drift of as-built wall pier

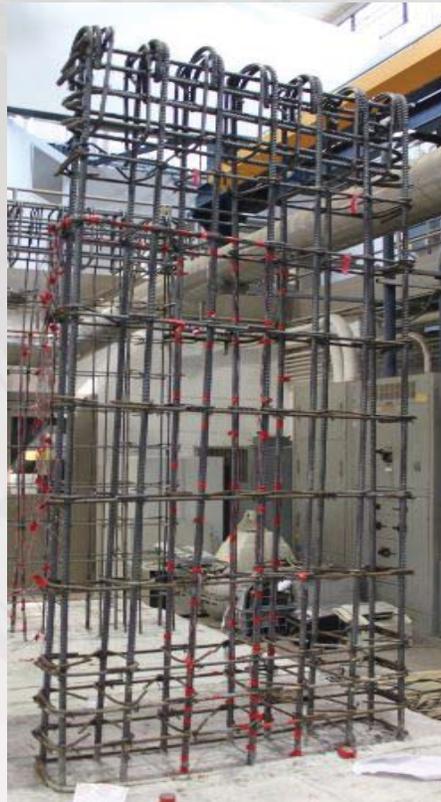
Modern code compliant wall pier reinforcement

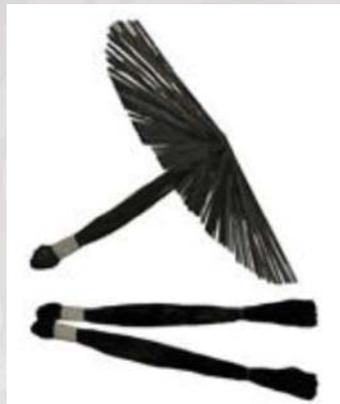
Carbon Fiber Reinforced Polymer Anchors

TABLE 1. CFRP Anchor Properties

Properties	Average Values
Tensile Strength	1,138 MPa (165 ksi)
Tensile Modulus	103 GPa (15 x 10 ³ ksi)
Tensile Elongation	1.10%
Diameter	19 mm (0.75 in.)

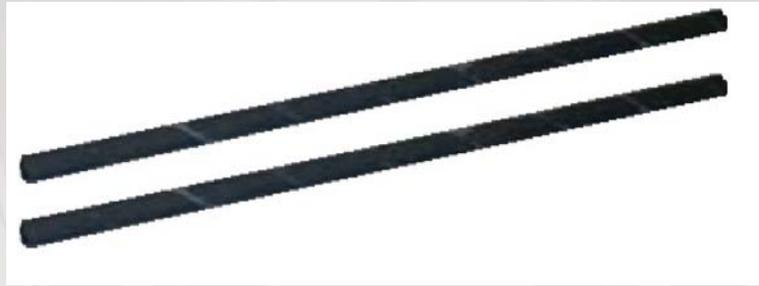
Carbon Fiber Reinforced Polymer Near Surface Mounted (NSM) Bars

TABLE 2. CFRP NSM Bar Properties

Properties	Average Values
Tensile Strength	2,068 MPa (300 ksi)
Tensile Modulus	131 GPa (19 x 10 ³ ksi)
Tensile Elongation	1.58%
Size	12.7 mm (0.50 in.)

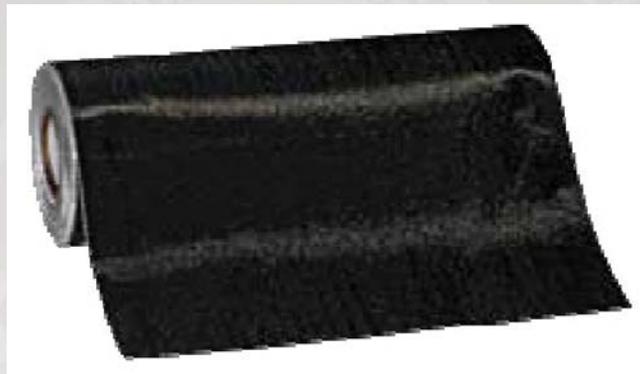
Carbon Fiber Reinforced Polymer Laminate

TABLE 3. CFRP laminate Properties

Properties	Average Values
Tensile Strength	1,240 MPa (180 ksi)
Tensile Modulus	74 GPa (10,700 ksi)
Tensile Elongation	1.7%
Thickness per layer	1.0 mm (0.04 in.)

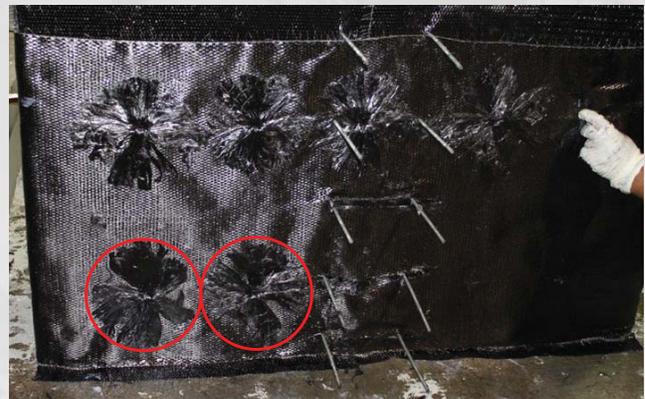
Transverse (Horizontal) CFRP Anchors (5+5)

- Two rows of 5 CFRP anchors
- Increase Confinement in Plastic Hinge Region
- Increase Clamping Pressure on Lap Spliced Steel Rebar

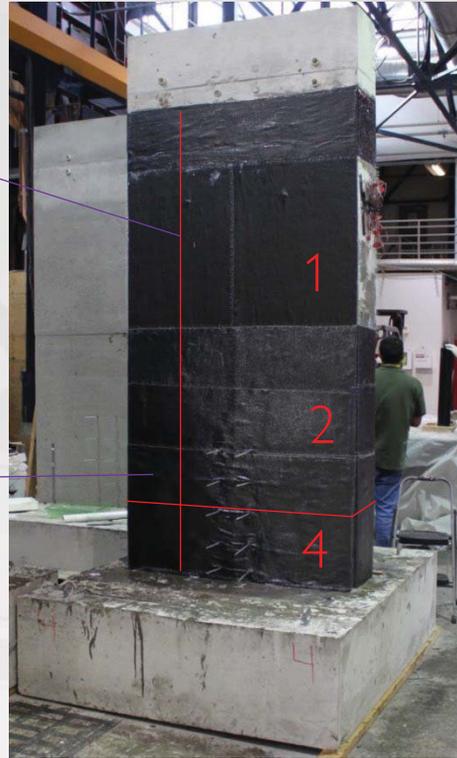
Carbon Fiber Reinforced Polymer Laminates

- Two vertical CFRP layers on each wall face to improve flexural bond
- 4+2+1 CFRP hoop sheets to improve confinement

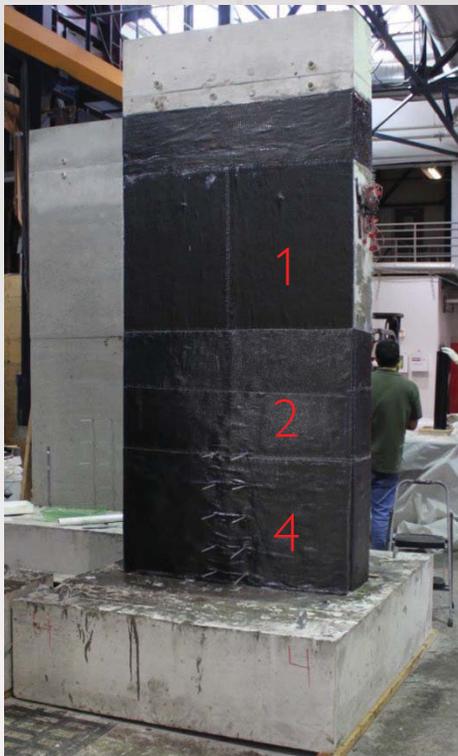
CFRP on each wall face:

- Vertical CFRP Anchors : 9
- Unidirectional Vertical CFRP Sheets : 2
- Horizontal CFRP Anchors : 5+5
- Unidirectional Hoop Direction CFRP Sheets: 4+2+1

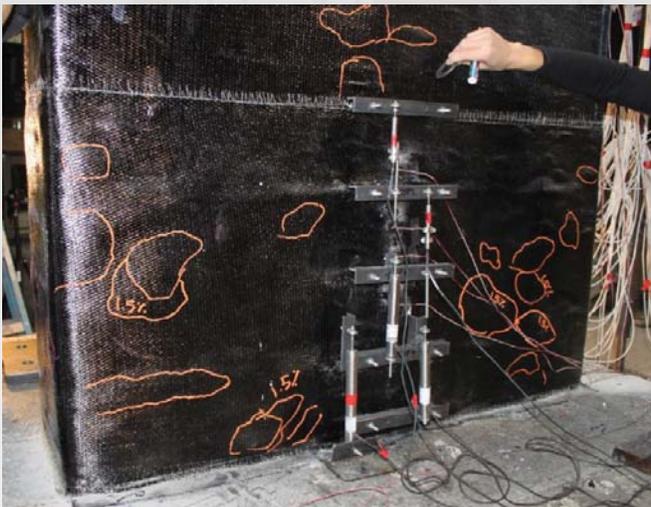
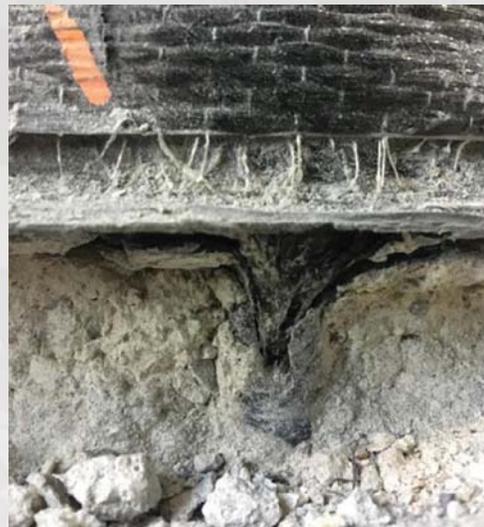
Behavior of retrofitted wall pier *R1*: (a) CFRP jacket debonding at 1.5% drift ratio; (b) vertical CFRP anchor failure at 2.0% drift ratio

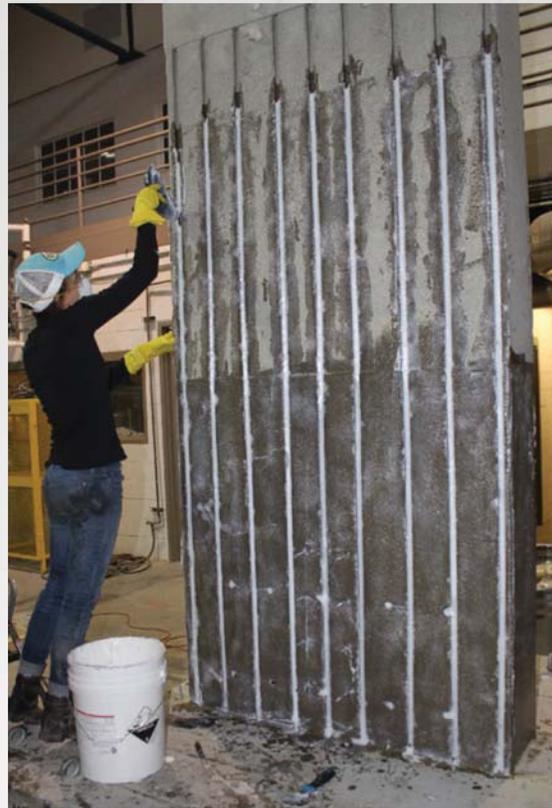
Near Surface Mounted (NSM) Bars

- Increases Flexural Resistance
- Creates Positive Connection between Footing and Wall Pier

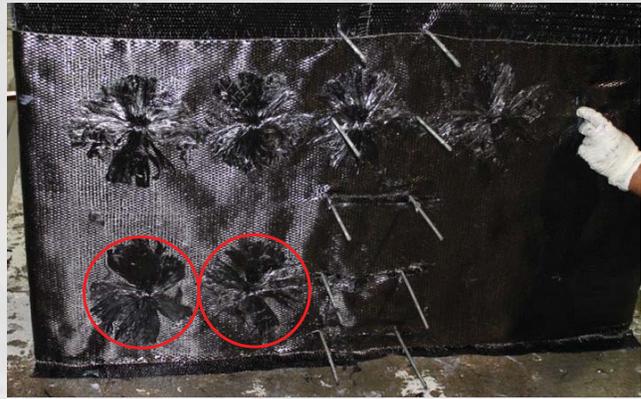
Horizontal CFRP Anchors (10)

- Increase Confinement in Plastic Hinge Region
- Increase Clamping Pressure on Lap Spliced Steel Rebar

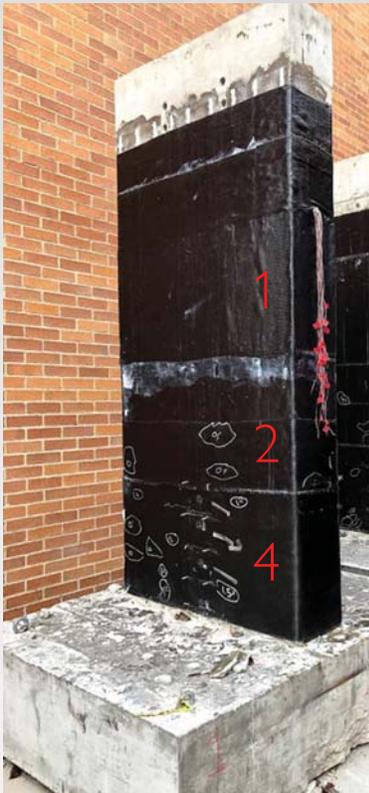
CFRP on each wall face:

- CFRP NSM Bars: 9
- Horizontal CFRP Anchors : 5+5
- Unidirectional Hoop Direction CFRP Sheets : 4+2+1

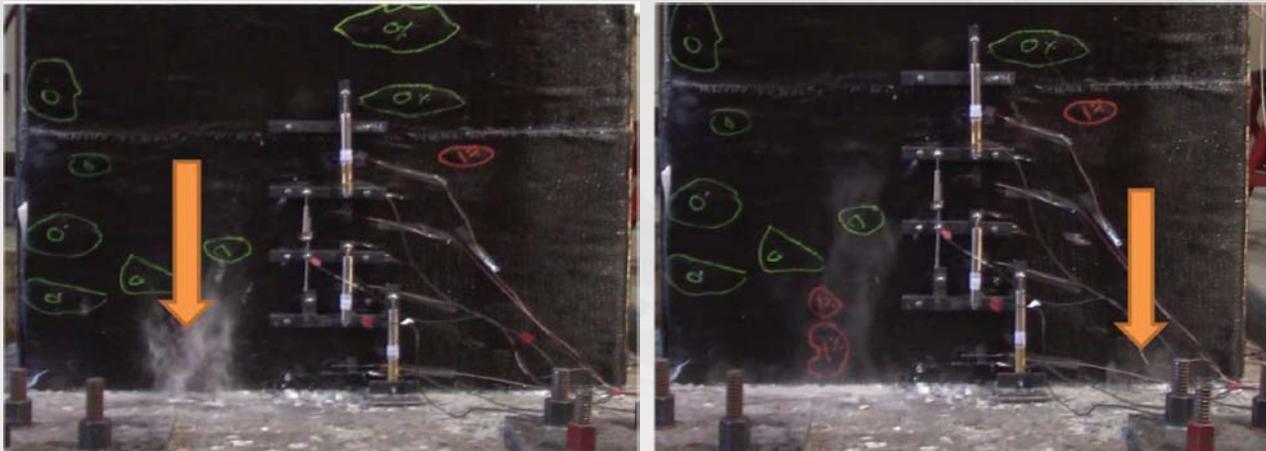
Retrofitted Wall Pier 2 damage

- NSM Bar Bond Failures

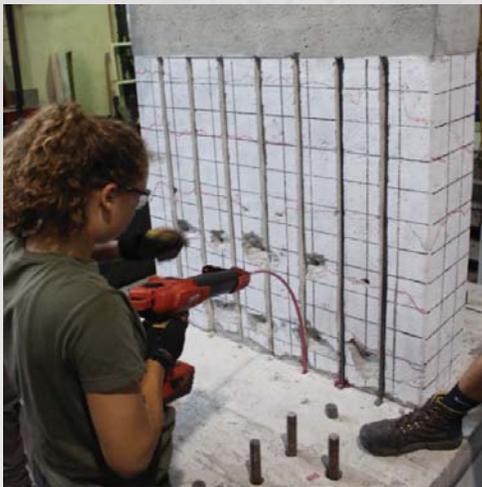
Mild Steel NSM bar placement

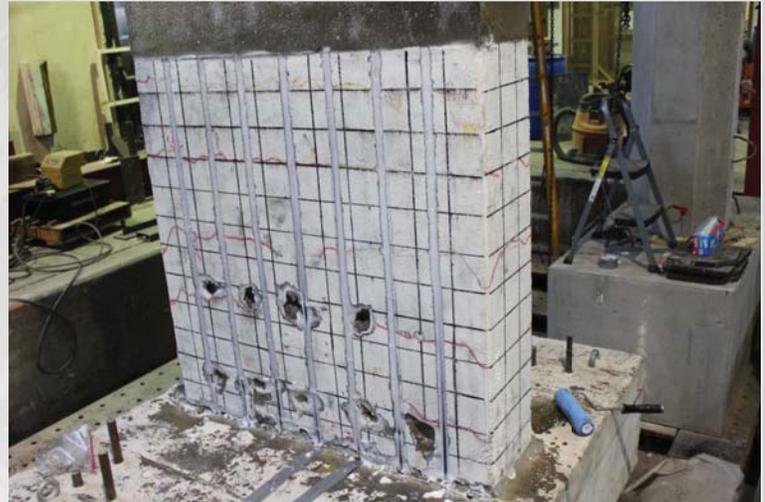
Epoxy coverage of Mild Steel NSM bars

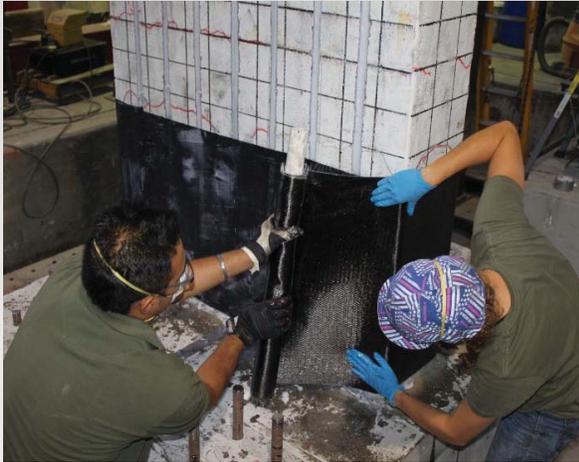
Application of CFRP hoop layers

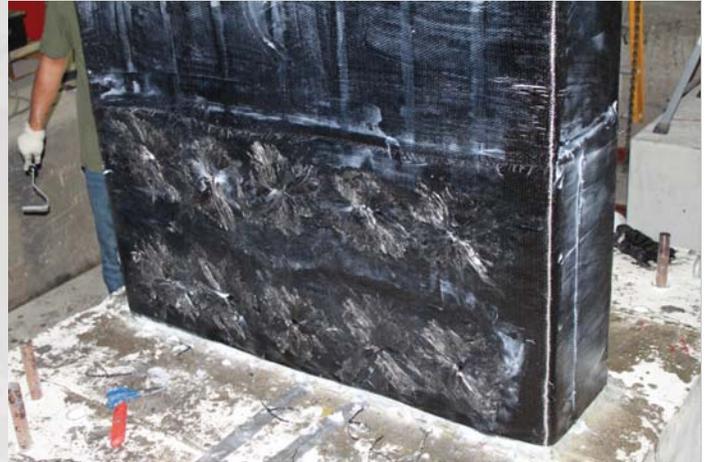
Transverse (horizontal) CFRP anchors

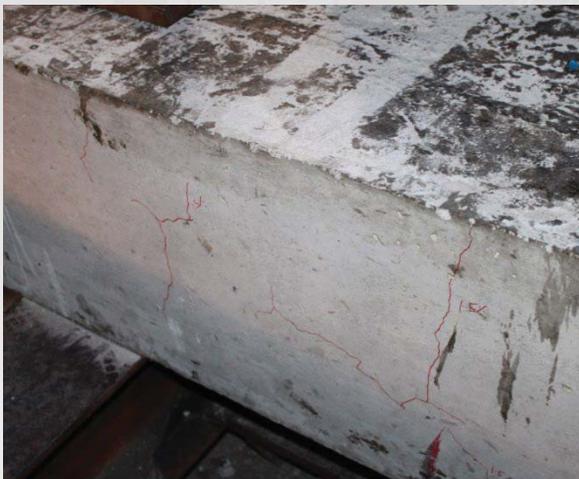
Footing crack at 1.5% drift ratio

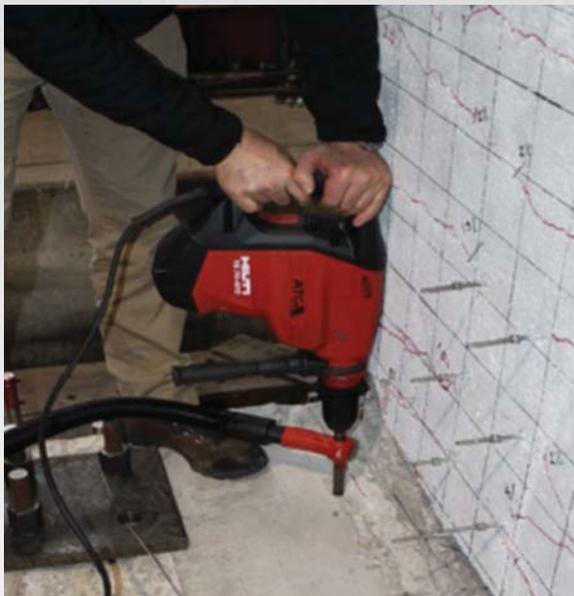
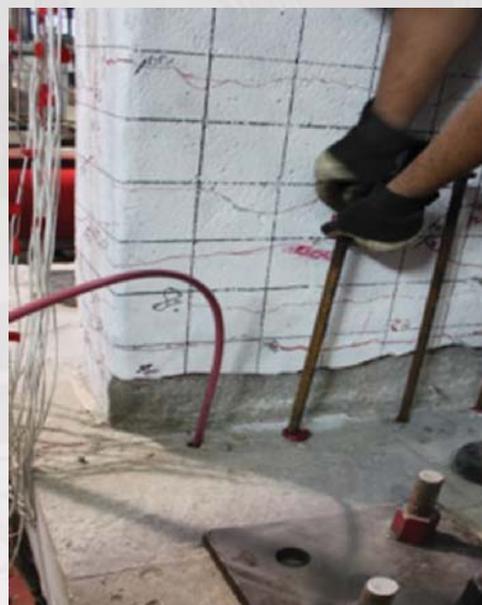
Headed steel bar installation process: (left) drilling holes; (right) headed bar placement for specimen MCRP

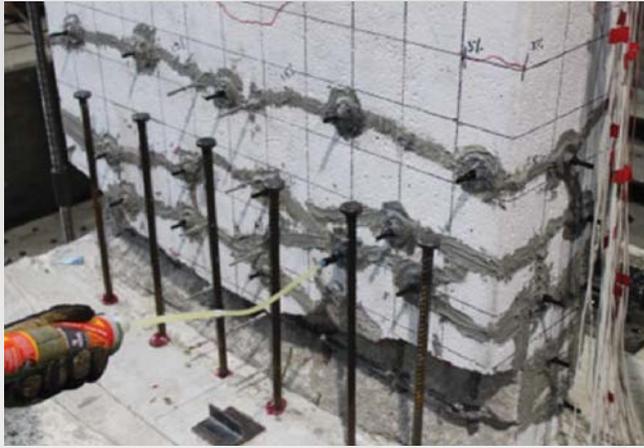
Epoxy injection of cracks for specimen MCRP

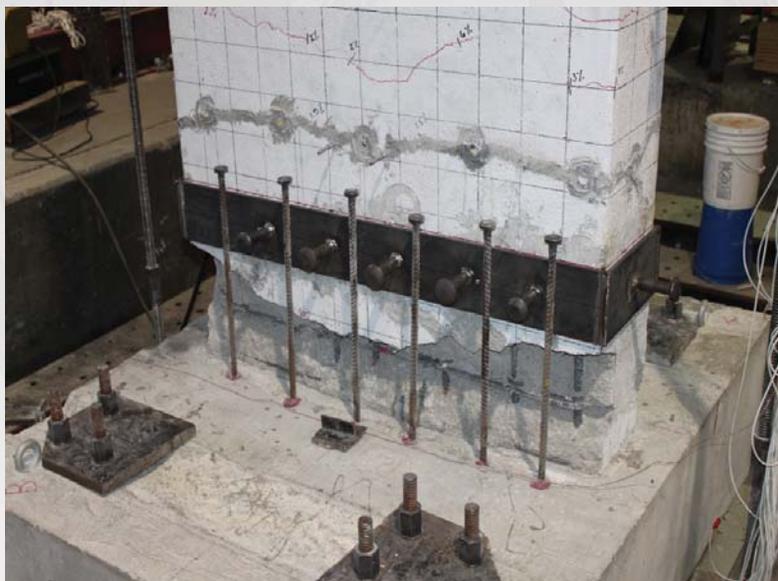
Steel collar with shear studs

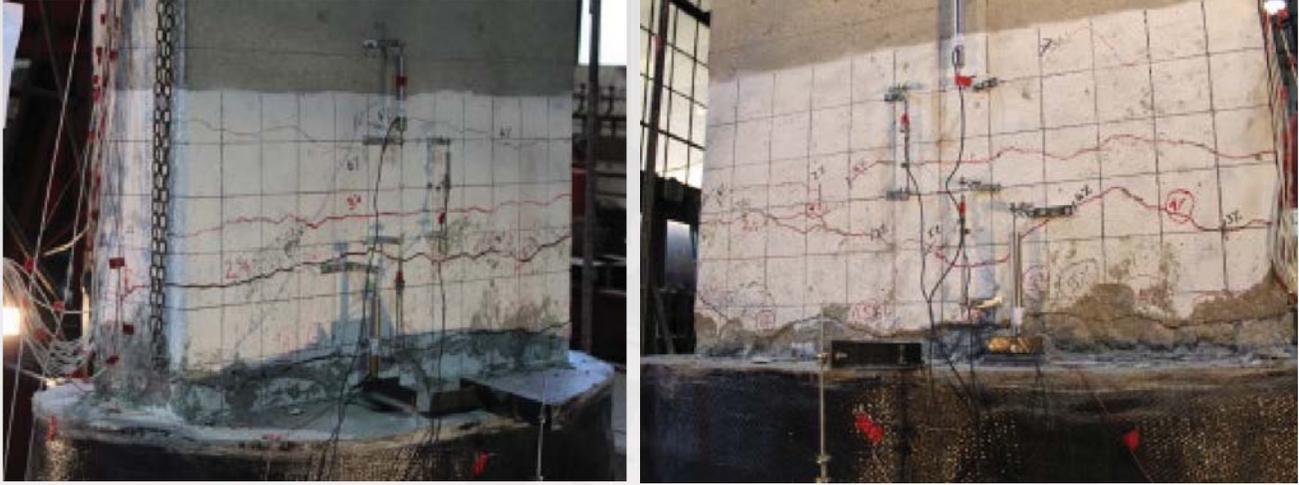
Experimental observation of specimen MCRP at a 5% drift ratio

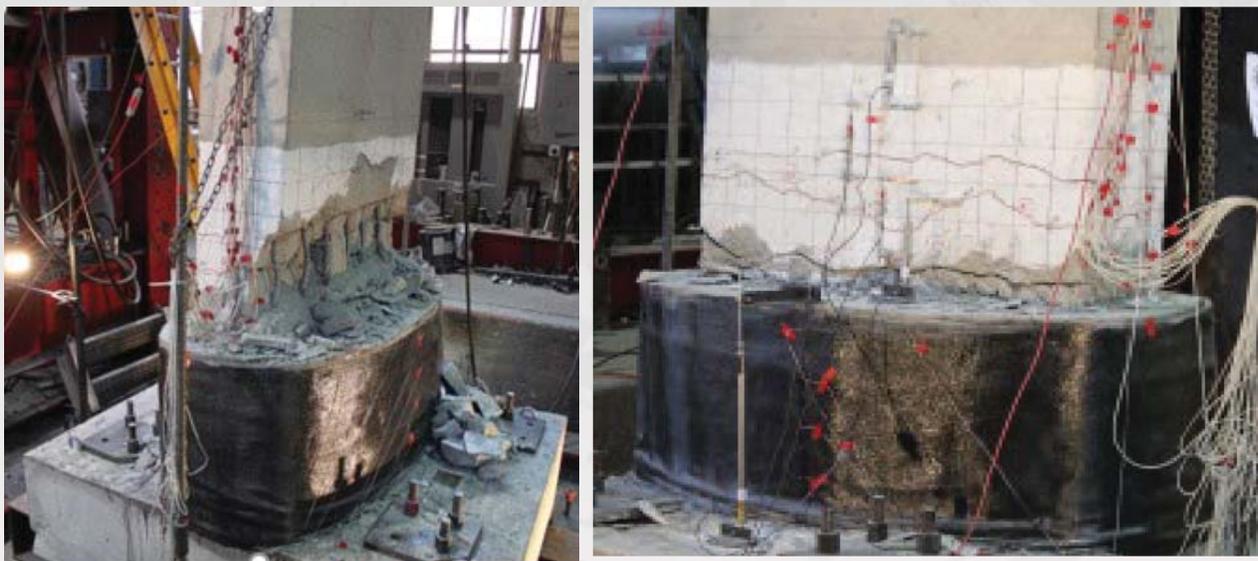
Failure of repaired modern code compliant wall pier: 6% drift ratio
